STAINLESS STEEL DRUM FAILURE AT OLEFINS PLANT

Brian J. Fitzgerald, Jeffrey P. Jones, Gregory E. Yeo, ExxonMobil Chemical Company

Prepared for the AIChE 2006 Spring National Meeting, EPC Conference

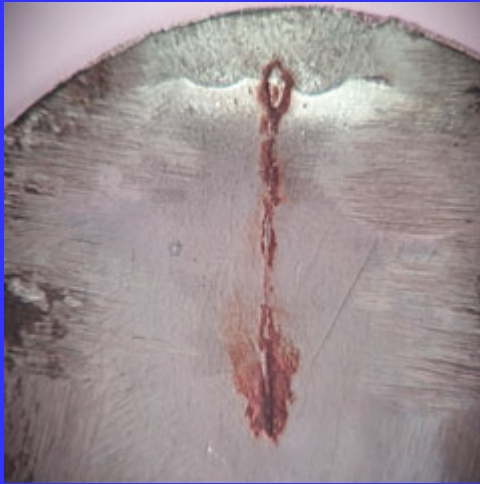
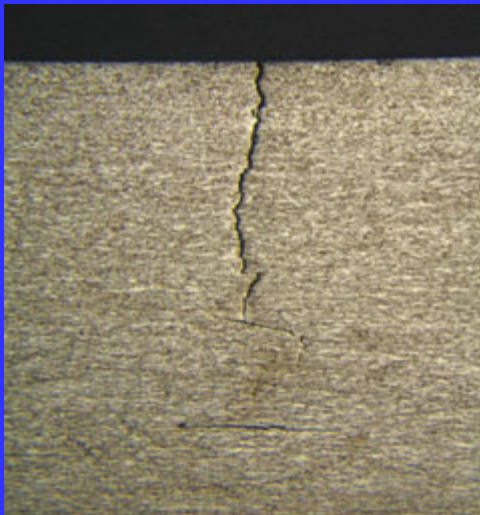
Feed Chiller Leak

- Two 304 SS Cold Spun Heads developed through wall cracks during 2nd start-up of a new olefins plant. The heads were fitted to horizontal vessels.
 - Reflux Drum: @ 9 o'clock position in head flange; 20 mm long; vessel diameter 2000 mm; head thickness 40 mm; D/t is 50.
 - Feed Chiller: @ 6 o'clock position in head flange; 12 mm long; vessel diameter 590 mm; head thickness 16 mm; D/t is 37.
- Heads were cold spun by same manufacturer.
- Heads were not heat treated after cold spinning; Cold spinning is not required by ASME code.
- Heads had magnetism in the flange and knuckle areas indicating formation of strain-induced martensite and cold work (residual stress) from cold spinning.

- Crack in base metal; stops at edge of heat affected zone
- ID view shows single, discontinuous crack
- Cross section shows non-branching, “step-wise” cracking
- Cross section hardness between R_c 29 to 40 (R_B 85 typical for solution annealed 304)

- Solution annealing of 304 stainless steel heads after cold spinning will remove strain-induced martensite and susceptibility to hydrogen induced cracking.
