Cooling Connections Development: PRR Status Report

July 10, 2001

Pixel Detector

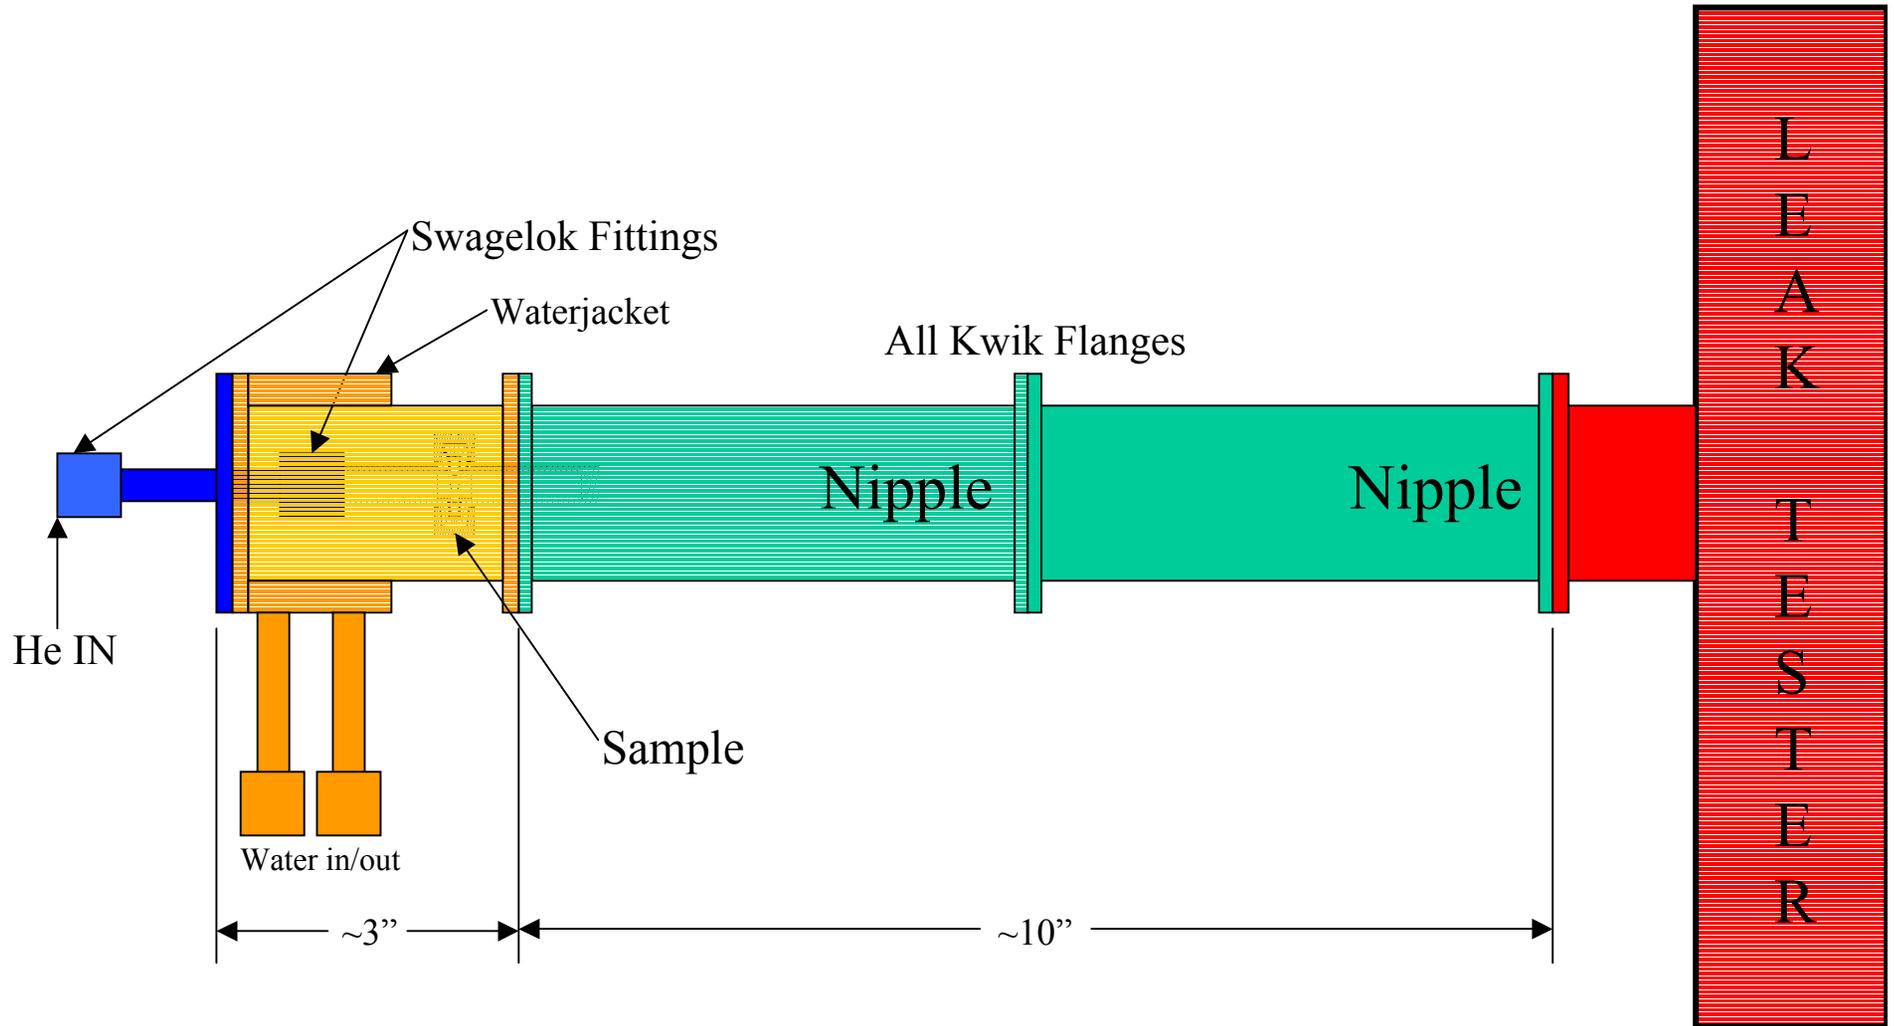
He Pressurized Leak Testing Setup

- **Fitting testing regimen begun**
 - Specific tests and sequence defined
 - Vacuum He leak test
 - Proof test at 8 bar, 1 hour
 - 1 bar pressure He leak test
 - Cold versions of above tests
 - 25 mrad Irradiation
 - New apparatus constructed and tested
 - Ability to Internally pressurize fitting with he and leak check (to > 10 bar)
 - Ability to cool fittings (to about –20 C) and perform same tests
- **Seals and Joining Methods tested**
 - Seals
 - Variseals (baseline)
 - Luer Lock
 - Joining Methods
 - Laser Welding (baseline)
 - Gluing

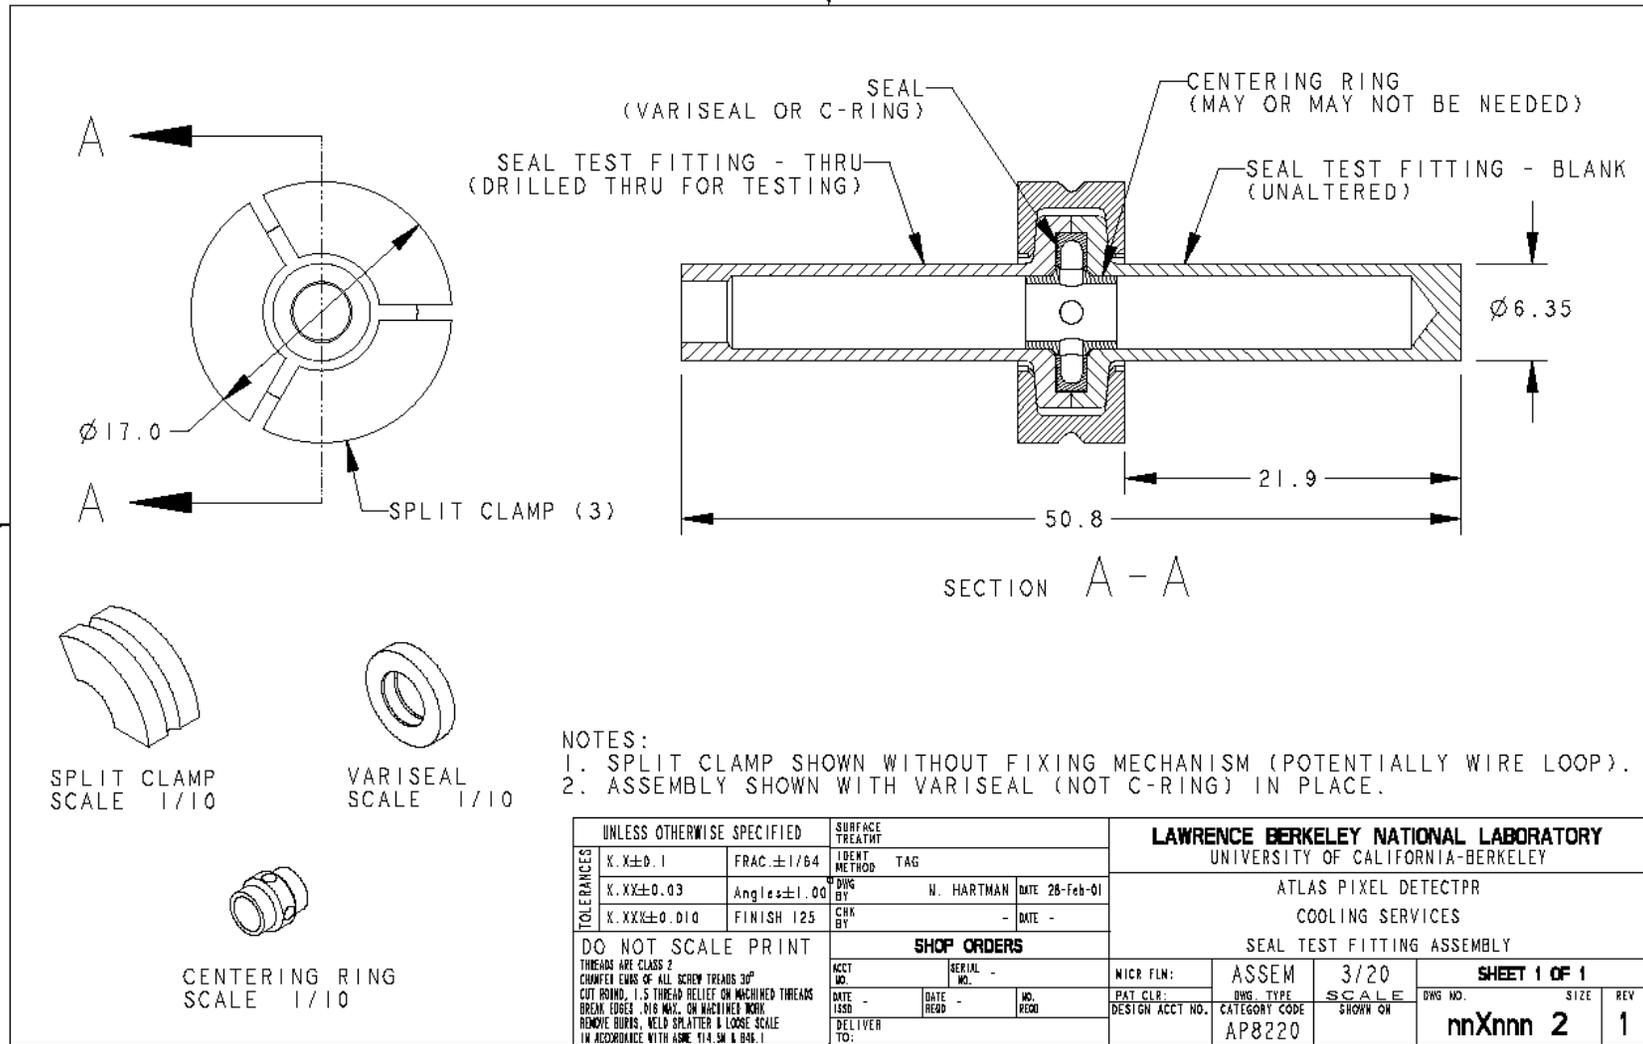
Fitting Geometry – Variseal Type

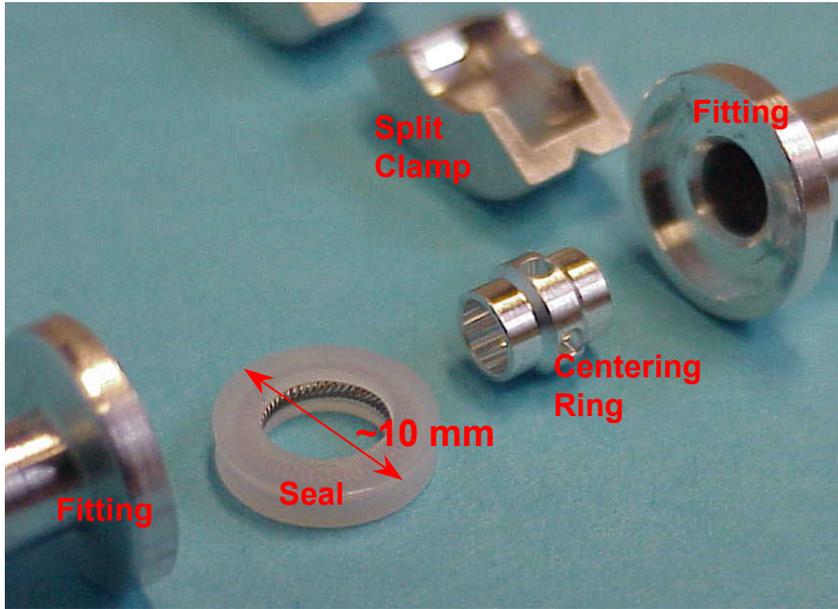
Fitting Test Specimens – Variseal Type

Fitting Pieces shown disassembled.

- **Variseals**
 - Current Seal Tests
 - Fittings made slightly undersize
 - 7 samples assembled
 - 7 samples passed vac check at $< 5e-10$ (Torr-L/sec)
 - 7 samples passed proof test ($< 5\%$ pressure change at 8 bar)

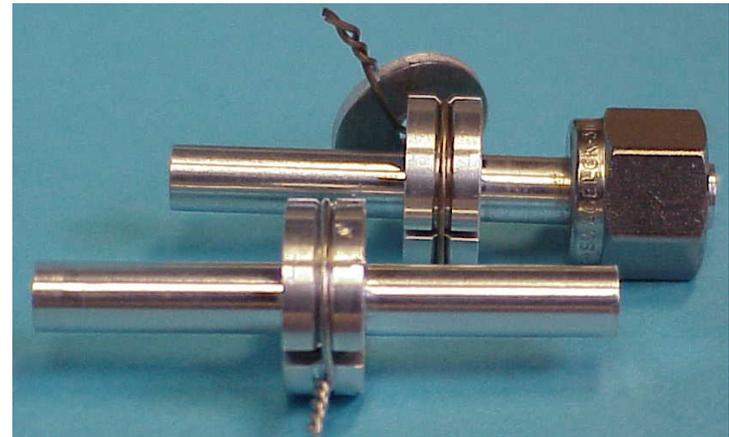
Assembled Fitting (one shown with Swage lock connector).

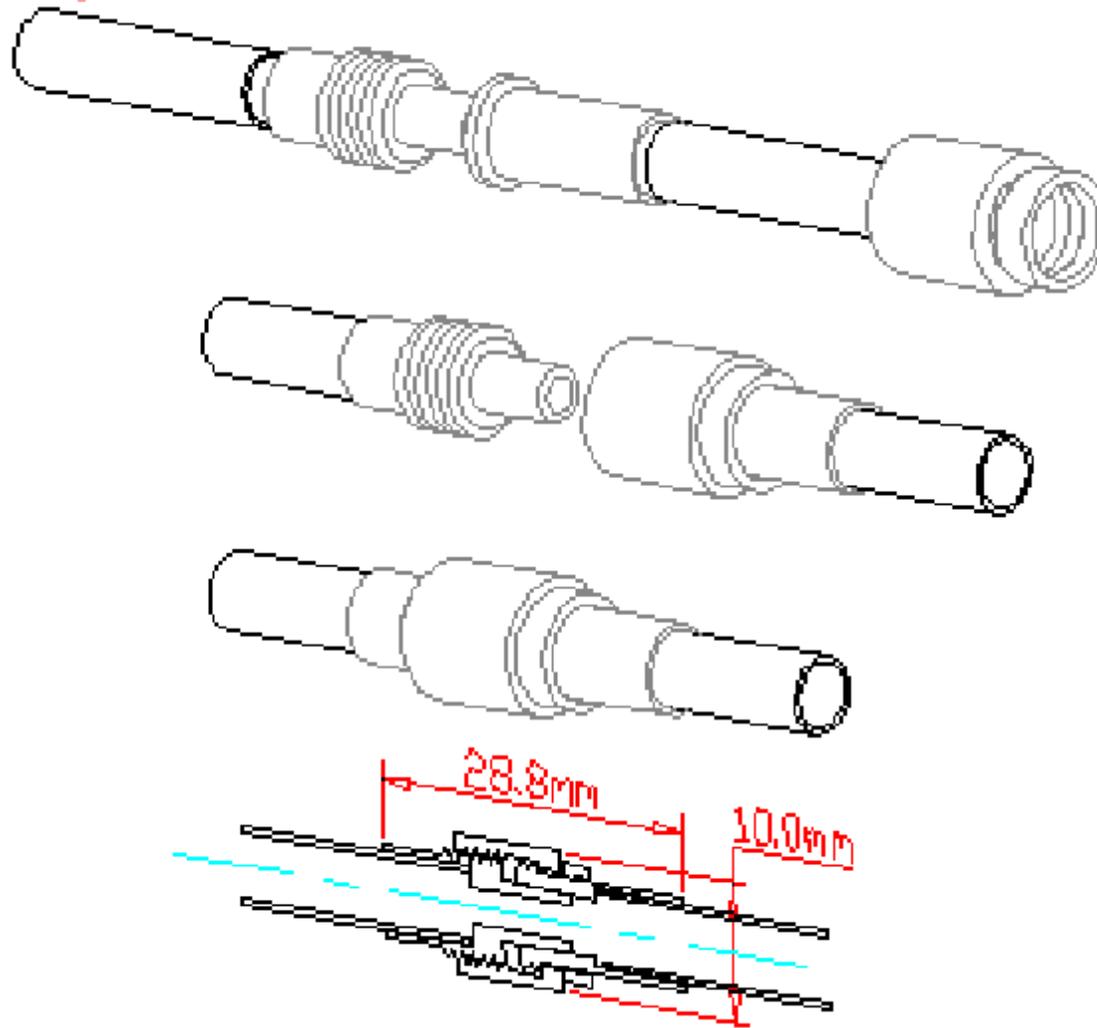
Fitting Geometry – Luer Lock Type

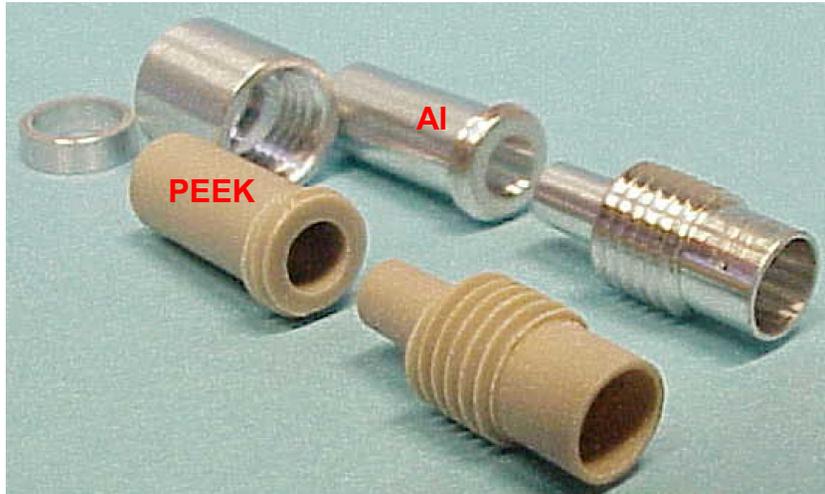
Fitting Test Specimens – Luer Lock Type

Luer Lock Pieces (PEEK and Aluminum).

- Only initial testing has been conducted (bubble tests in alcohol)
 - Al/Al samples seem to seal well with some torque
 - PEEK seals are too soft
 - Full testing regimen has not yet begun

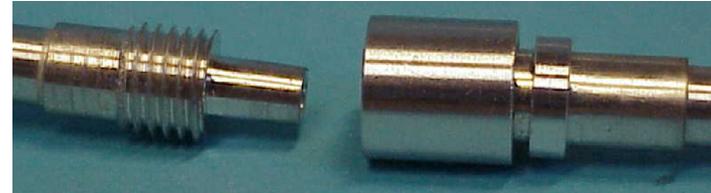
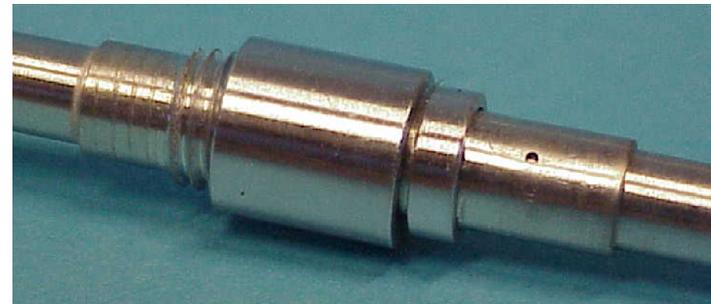
Assembled Fitting.

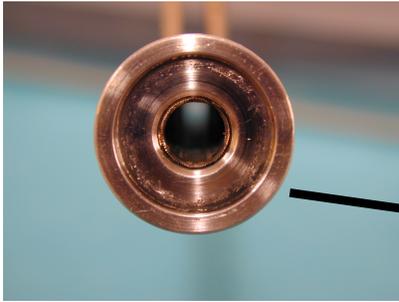
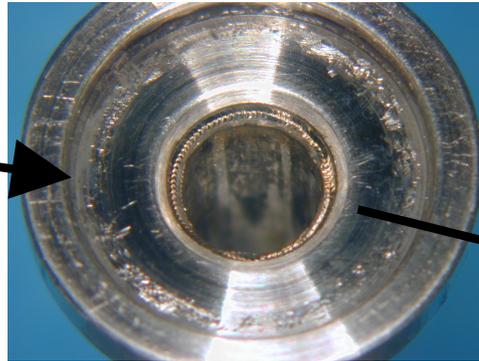
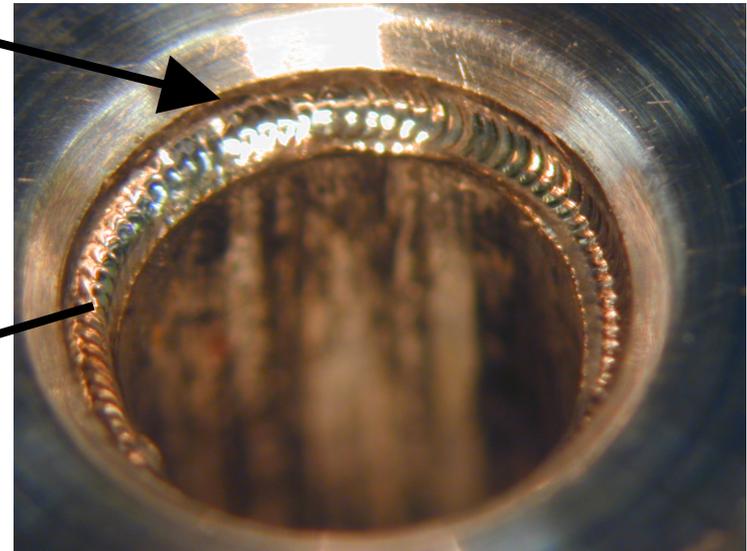
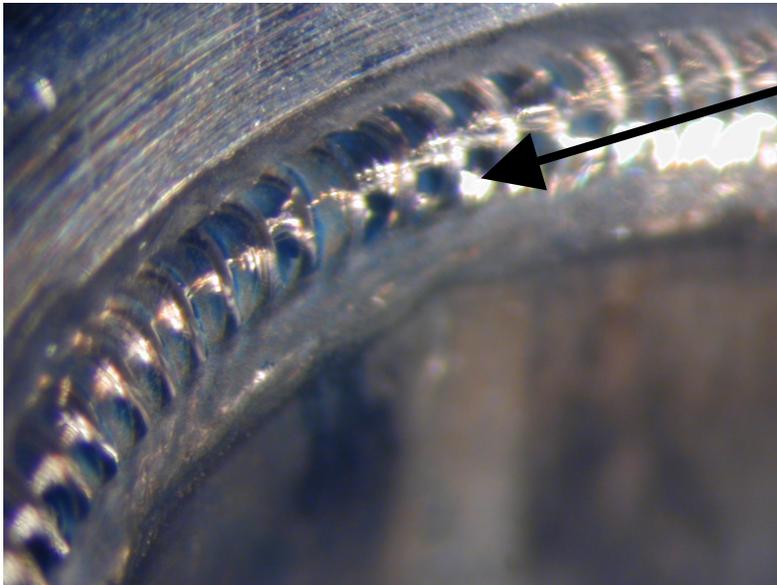
Joining Methods – Laser Welding

- **Laser Welding**
 - 5 samples fabricated at EB industries in Massachusetts
 - Weld penetration approximately 2 times wall thickness
 - Leak checked to $< 1e-10$ Torr-L/sec
 - Vendor has given “okay” to actual tube shape and size
 - Method is inexpensive (average cost of 80 CHF per sector)
- **Gluing**
 - 4 Glue samples fabricated
 - All samples leak checked to $< 1e-10$ Torr-L/sec
 - Samples irradiated to 25 Mrad in C_3F_8
 - All samples passed leak check after irradiation ($< 1e-10$ Torr-L/sec)
 - However, glue showed strange “spots” that must be investigated
 - C_3F_8 used in test had already been dosed to **> 150 Mrad** (in previous testing)
