## Cooling Services Joining Techniques: Progress Report

**December 13, 2000**

# Pixel Detector

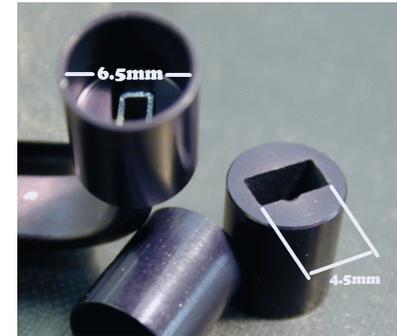
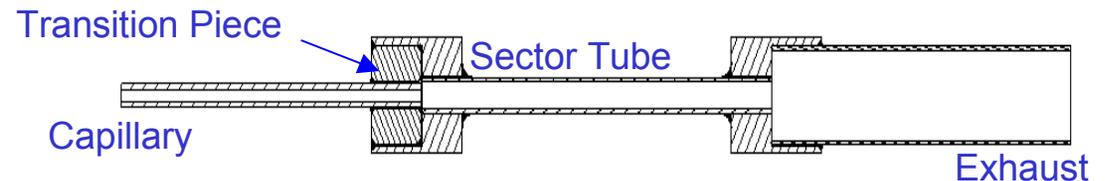
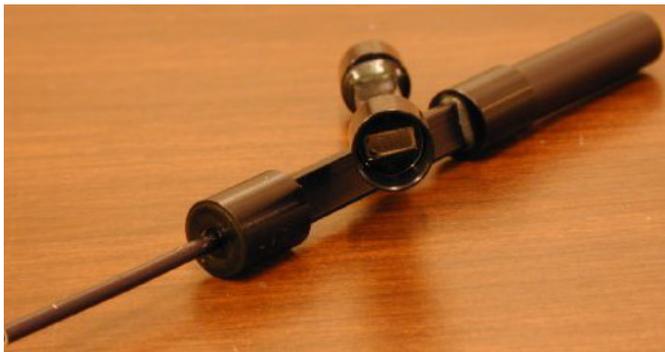
- **Test piece models all three connections (but no electrical breaks)**
  - Sector termination
    - rectangular to round transition
  - Capillary Termination
    - small to large diameter transition
  - Exhaust Termination

Samples black anodized to simulate worst possible bond

- **Samples prepared for Thermal Cycling tests**
  - Un-irradiated samples only
  - Immersed in  $-40$  C fluid to cause thermal “shock”
  - Leak rate checked before and after cycling, at internal pressure of  $>6$  bar
  - Thermal cycles repeated to failure, with measurements after each cycle

- **Tests showed large leaks after small number of thermal cycles**
  - Leaks occurred different places in different samples (there was no one culprit)
  - De-lamination was visible between epoxy and aluminum– indicating bad adhesion
  - Of 8 samples, 6 developed large leaks, and only 1 survived 10 cycles
  - 4 samples that had previously checked OK did not pass the initial pressure test – implying that some damage was done during previous pressure cycles or during handling

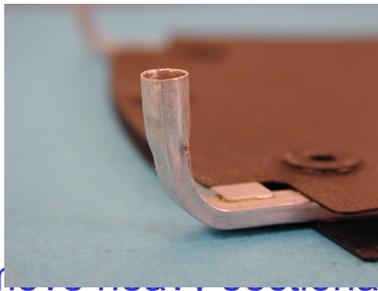
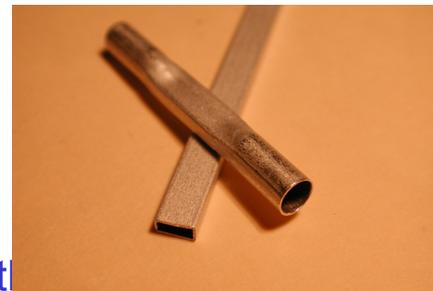
- **simple changes could eliminate many problems**
  - Use chromic acid etch for surface prep – eliminate black anodization
  - Eliminate rectangular to round junction at sector (possible stress riser) – using swage

- **Bonded Joints**
  - Have not proved to be robust so far, but have known problems
    - Surface prep has been very poor (black anodization)
    - Heavy sectional transitions and stress risers (corners) have been present
  - Plans and solutions
    - Use adhesive manufacturer's recommended surface prep (chromic acid etch)
    - Reduce heavy sectional transitions (already incorporated in design)
    - Remove stress risers at rectangular transitions (already accomplished with tubing swage)
  - Yet to be addressed
    - Electrical breaks (peek or alumina) need to be incorporated in bond samples
    - Irradiated samples need to be thermally cycled and pressure tested
      - Previous radiation testing has shown no reason to believe that there will be problems

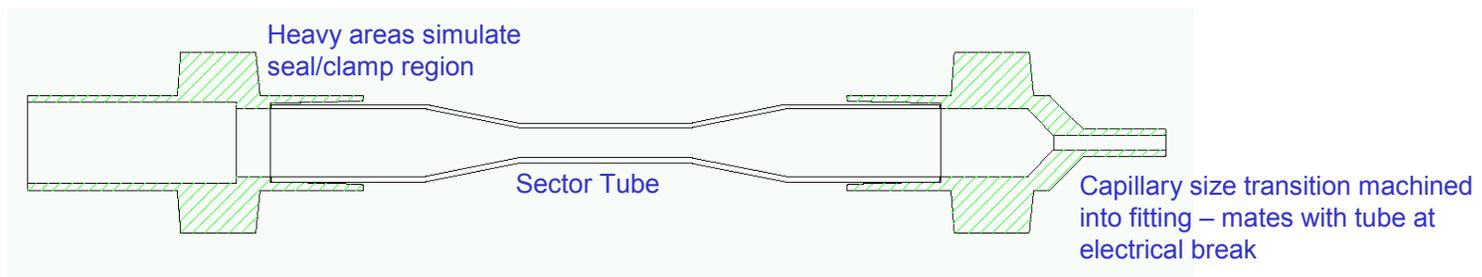
- Remove heavy sections changes thermal stresses problems during thermal shocking

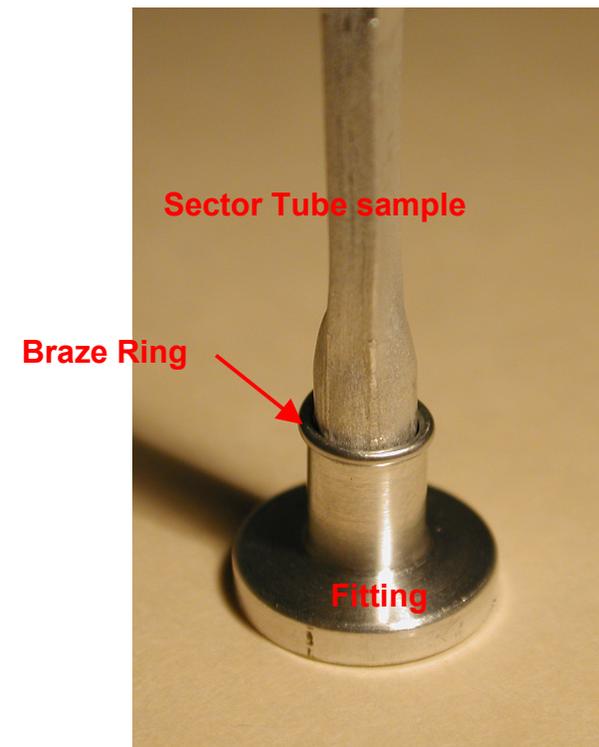
- **In Response to previous successes, torch brazing was pursued instead of furnace brazing**
  - Approach is to fillet joint, rather than relying on capillary
  - Same pieces used for bonding and brazing
  - Al-Si filler rod used under propane torch
  - In some cases ring was applied before heating, in others rod was hand-fed, as in traditional fillet technique
  - Standard and non-corrosive fluxes tried
  - First samples consisted of sector termination junctions only
  - Future samples will mirror bond testing type

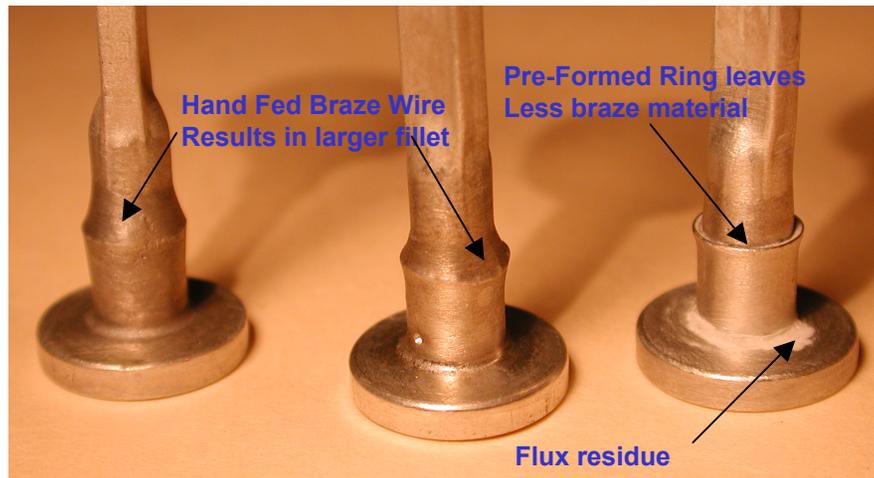
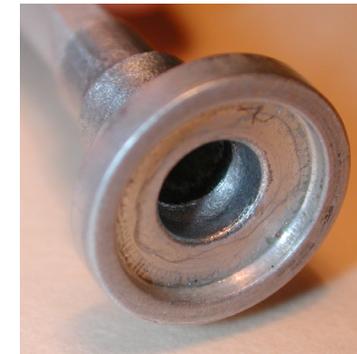
- **Torch brazing turned out to be generally successful**
  - 12 samples were constructed and **all** of them passed He leak testing
  - Non-corrosive flux was difficult to remove, and thus abandoned for more conventional fluxes
  - No samples were melted, however, some tube deformation was seen at temperature (no provisions were made to support the tubes during brazing)
  - Pre-formed braze rings were given up for manually feeding (technicians felt manual feeding was easier to work with)
  - Sealing surfaces have not been tested after brazing

Though no special care was given, excellent braze penetration was seen up to 6 mm away from fillet

- So far, torch brazing has been very successful
  - All samples pass leak checking
  - No samples have been lost during the braze process (operators find it very controllable)
- However, issues need to be addressed
  - Tubes need to be supported so that they don't deform at temperature (this should pose no problems)
  - Sealing surfaces need to be tested after being heated to close to melting point
  - Flux removal needs to be checked (to make sure that there are no lingering corrosion problems, and that seal surfaces are not degraded)
  - Low temperature solders address many of these problems, but have categorically failed (we do not plan on further investigation)
- In the Future
  - Alumina breaks need to be incorporated in braze samples (torch or furnace?)
  - Braze samples need to be irradiated in  $C_3F_8$  and tested in all manners

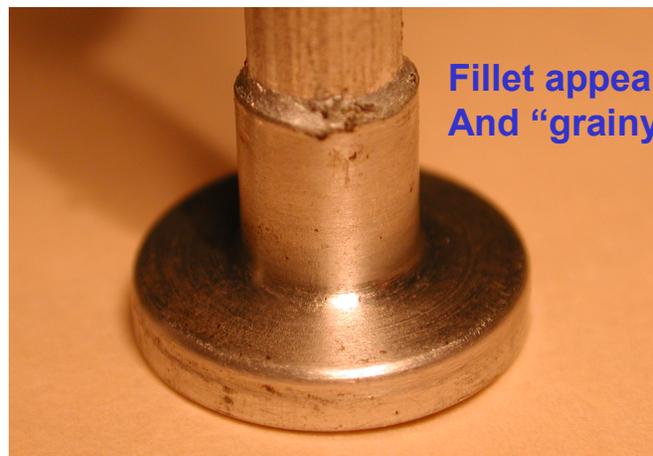
- **Commerically available low-temperature joining techniques were attempted in conjunction with sct research**
  - Products from “Techno-weld” and “Castolin-Eutectic” are available which join aluminum at temperatures below 380 C
  - Products contain mostly zinc, with some other elements (Al, Cu, Mg, Mn, Cd....) and need no flux
  - Technicians attempted “soldering” fittings together using same geometry as for brazing and bonding (also attempted SCT fittings)
- **So far, all attempts with low-temperature materials have failed**
  - Joints look clean, but do not pass He leak check
  - Qualitatively, filler material looks porous
  - No special cleaning techniques were used – may be a problem

Fillet appears porous  
And “grainy”
