Tax Week Fabrication Update

April 16, 2015

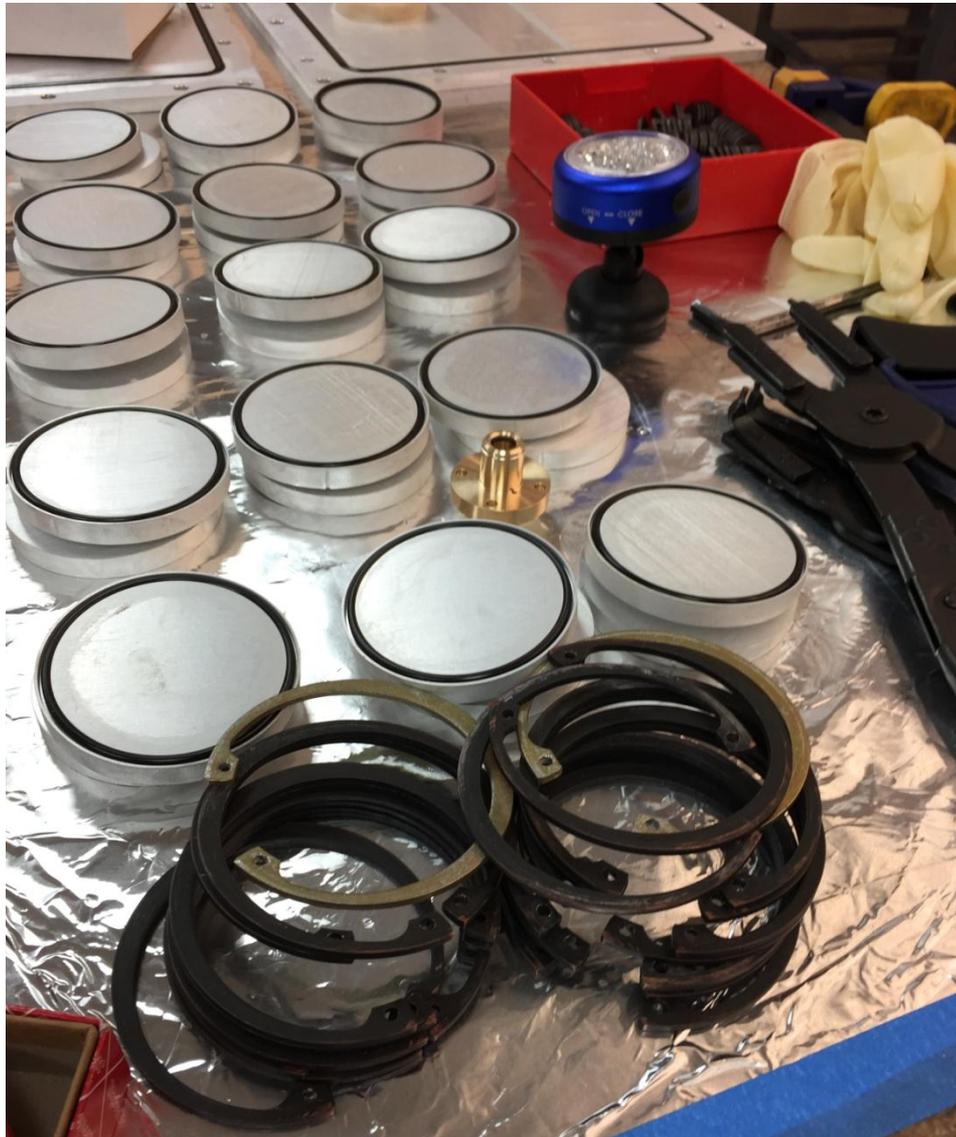
Tuner port blank-offs for vacuum checking

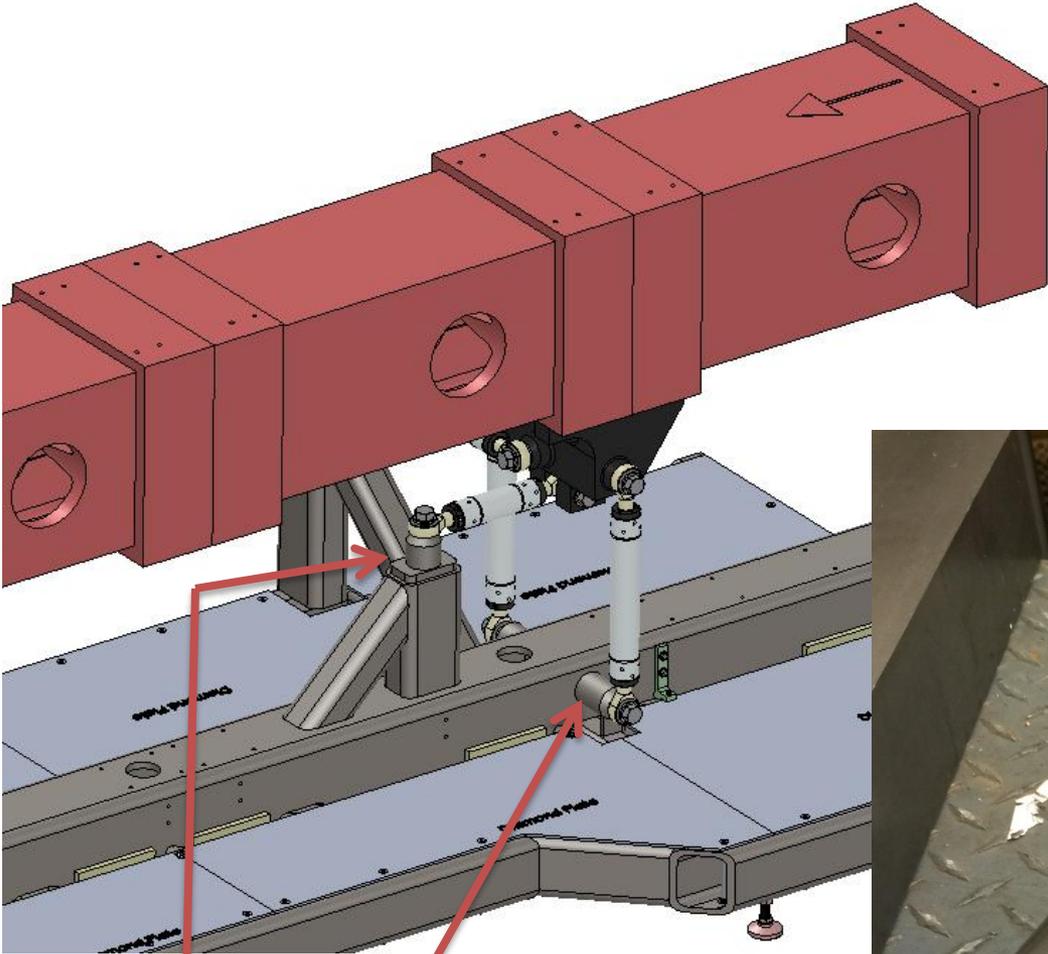
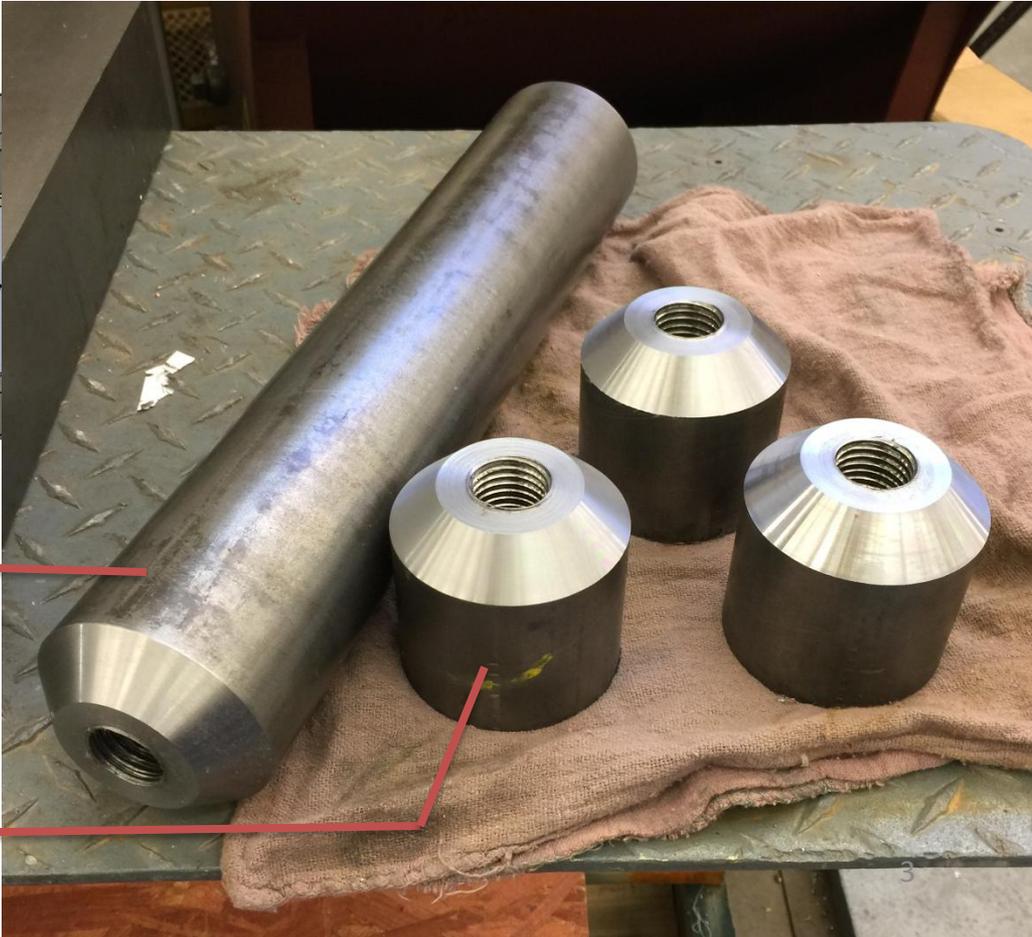
Support Frame continues to grow

The red arrows are new pieces added since last update

Precision strut attachment post
are being fabricated

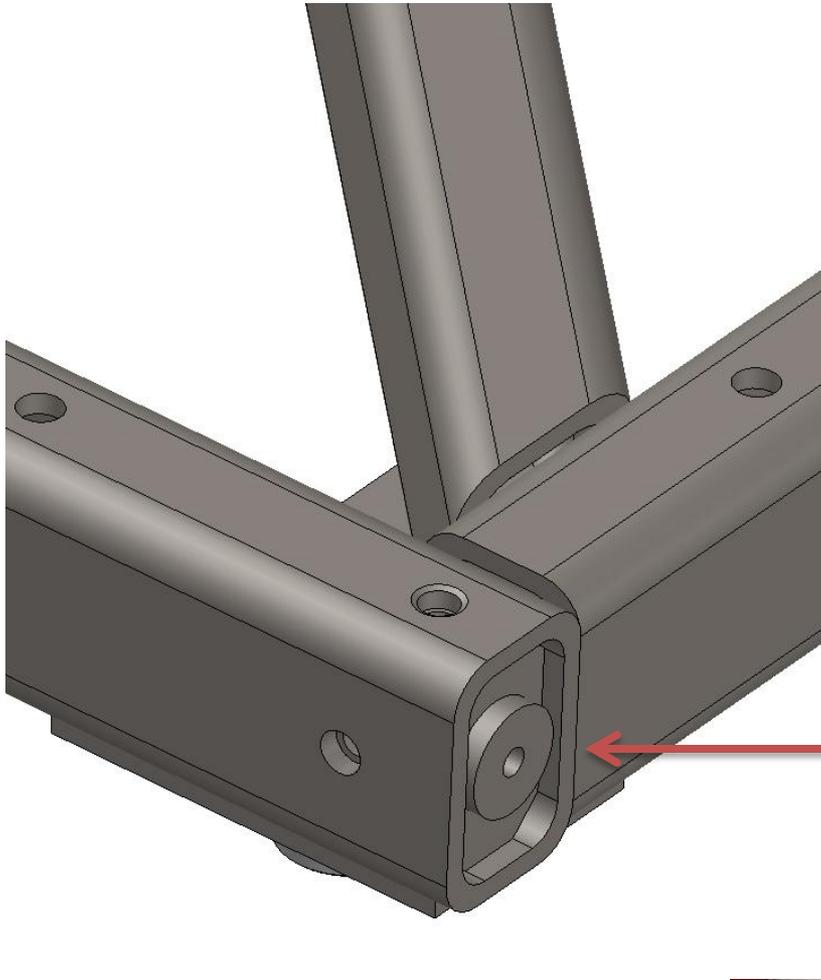
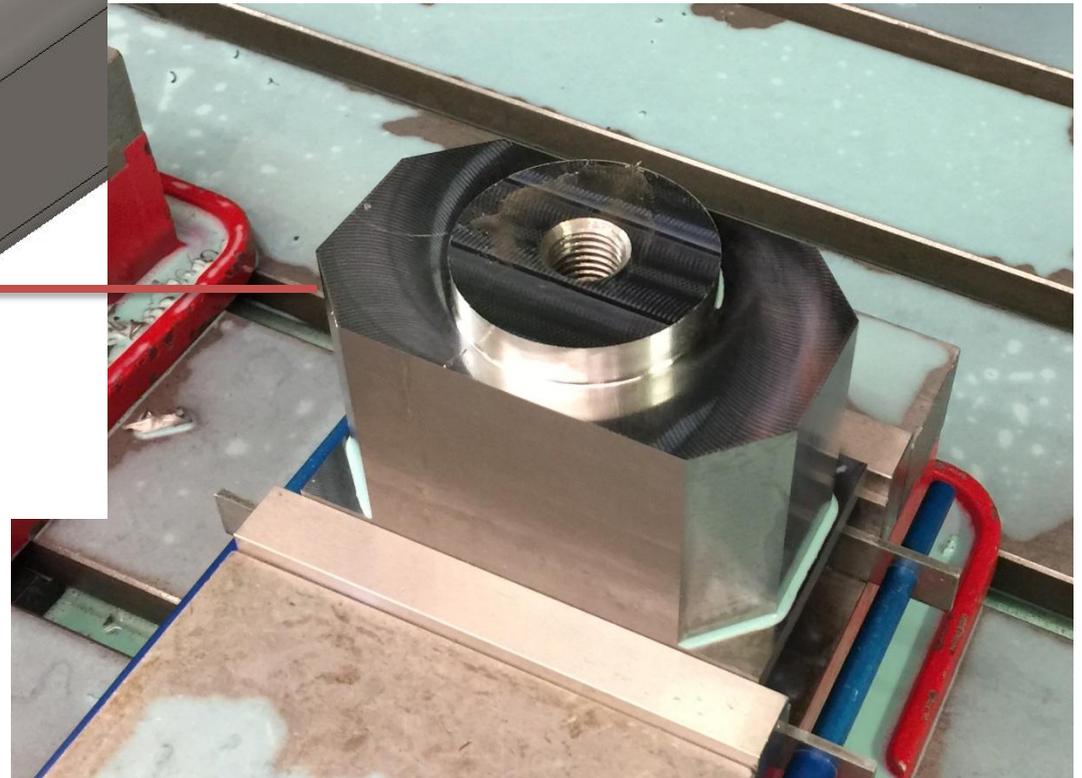
End blocks for the corners of the support frame are being fabricated

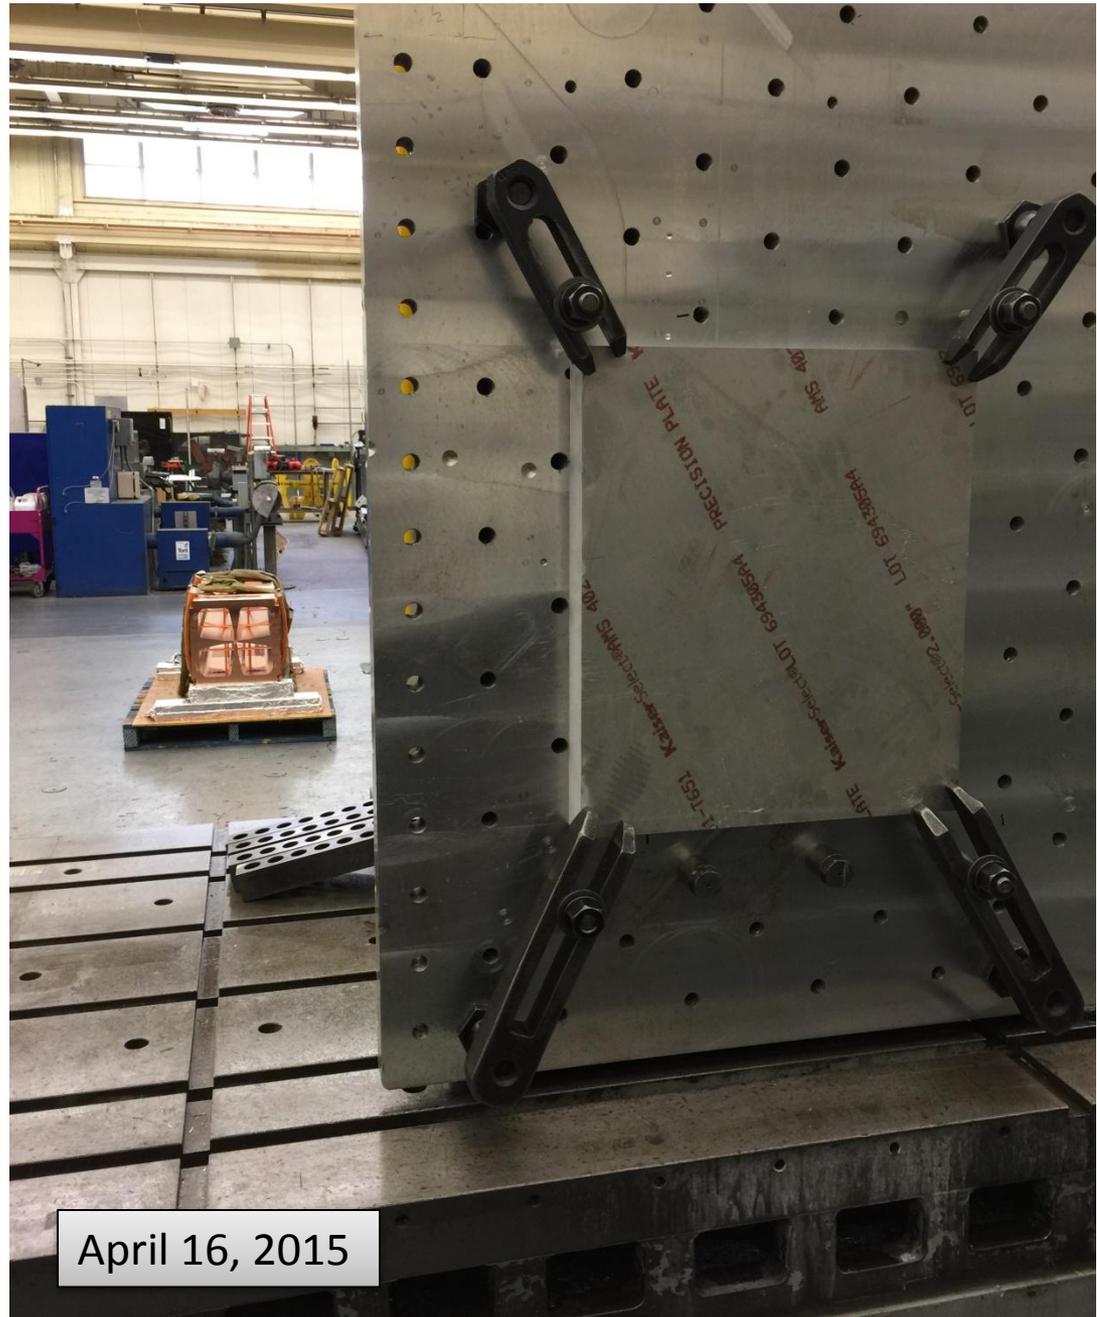
End machining of the modules is a little delayed.

The end wall machining program will be test run into aluminum blanks before touching copper.

Module 1 is in the background and the test aluminum plate is mounted in the G&L in the foreground about to be started.

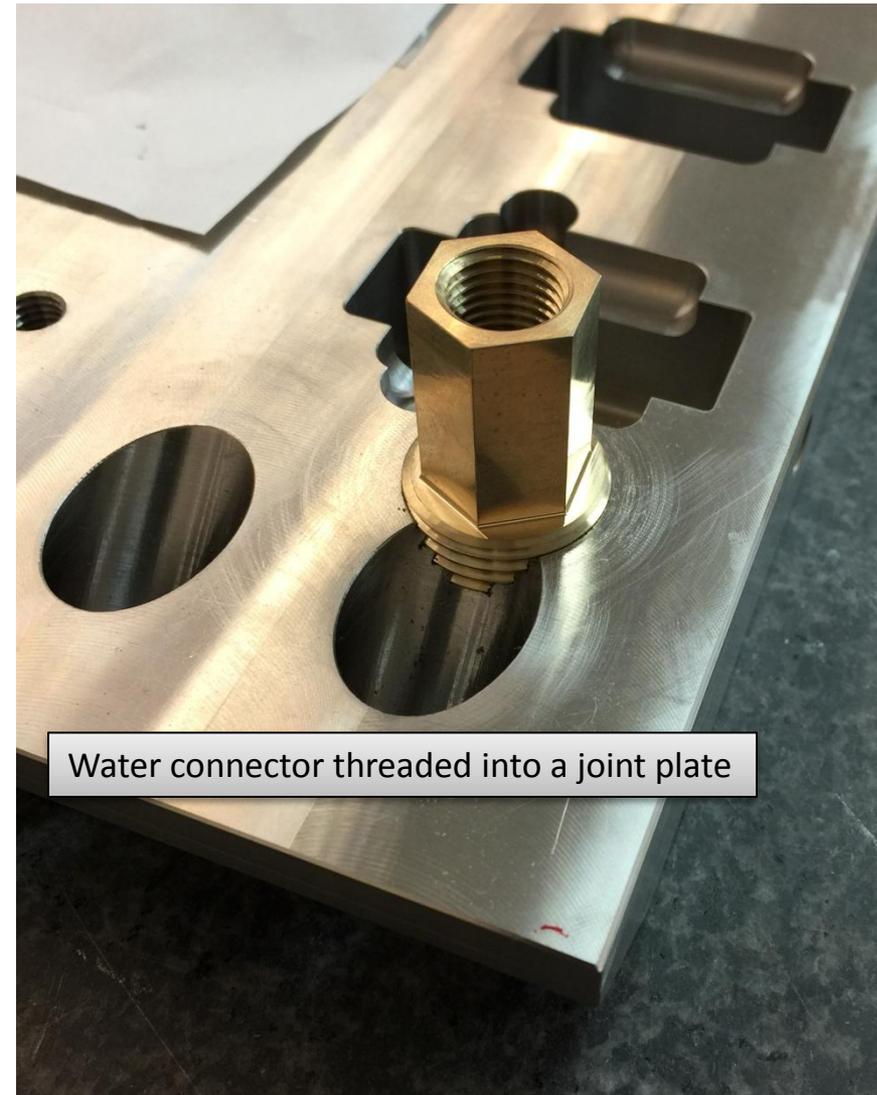
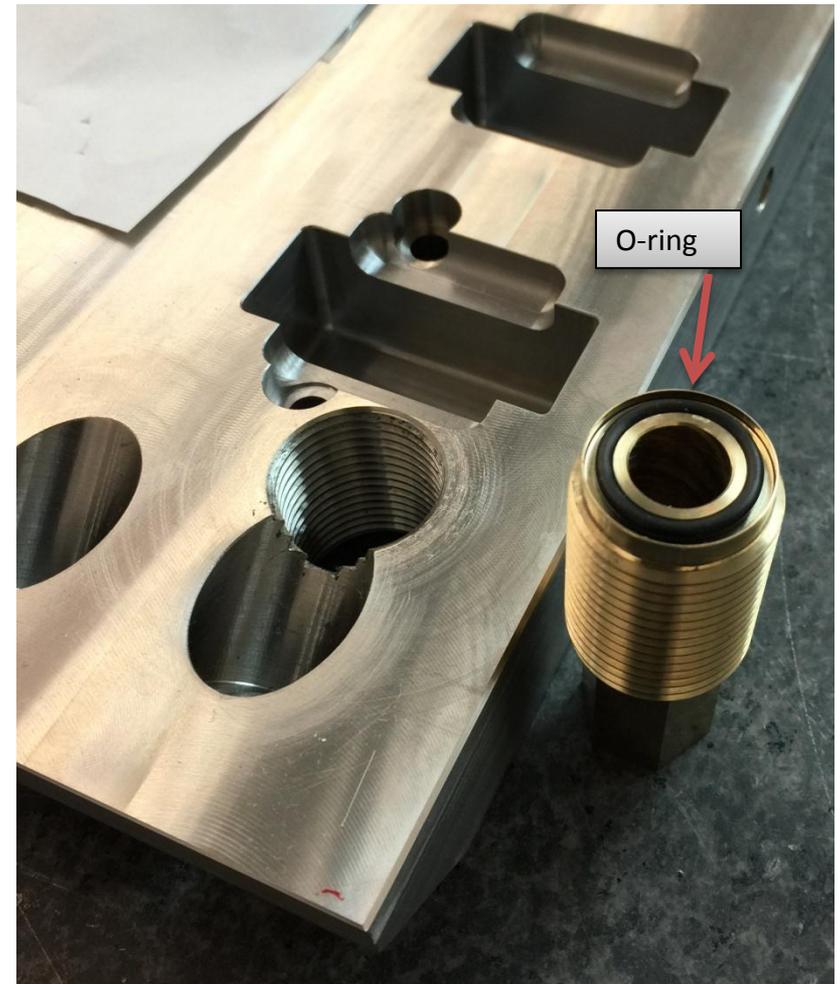
Cooling channel water connector

Prototype worked well. 99 more ordered. Probably will be fabricated at an outside shop

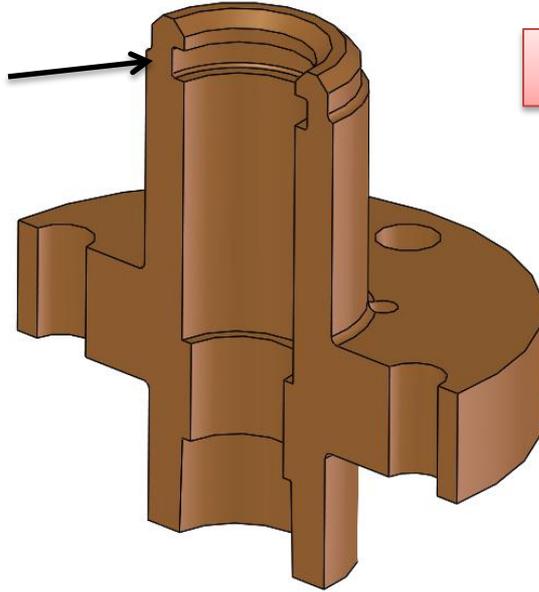
Internal O-ring groove

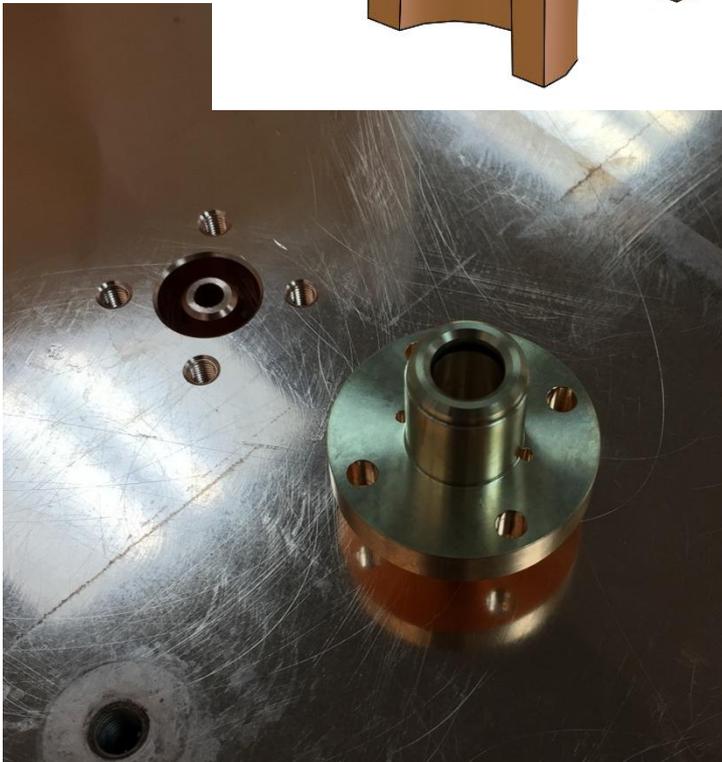
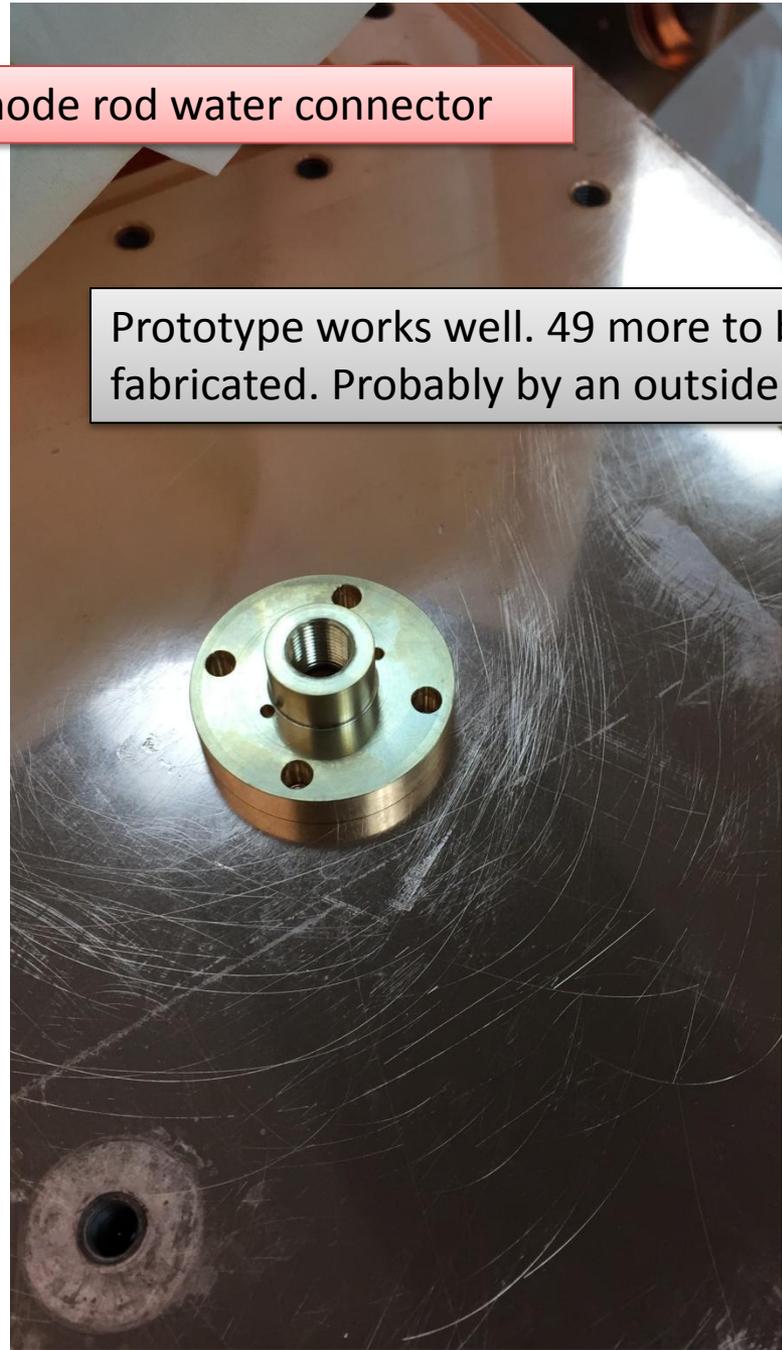
Pi-mode rod water connector

Prototype works well. 49 more to be fabricated. Probably by an outside shop.
