STAINLESS STEEL DRUM FAILURE AT OLEFINS PLANT

Brian J. Fitzgerald, Jeffrey P. Jones, Gregory E. Yeo, ExxonMobil Chemical Company

Prepared for the AIChE 2006 Spring National Meeting, EPC Conference

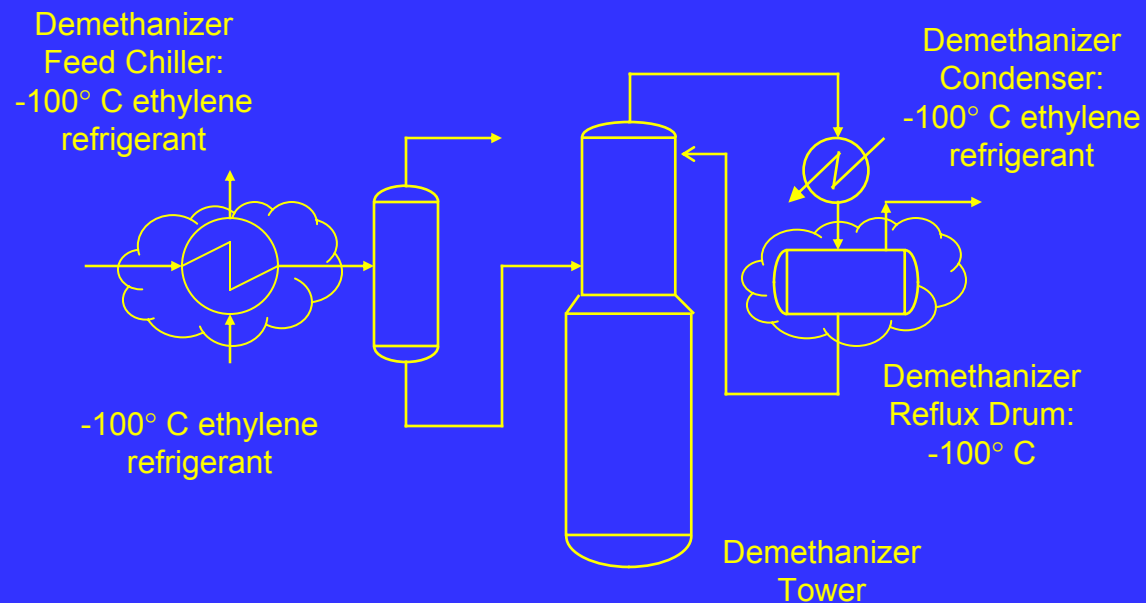
Overview of the Facility

- New olefins plant in Singapore: Initial startup 2001
- Modern, efficient design with low temperature demethanizer and chilling train with -100°C ethylene refrigerant
- All equipment shown 304 SS with design temperature $\leq -100^{\circ}\text{C}$
